# Manhole Inspection Summary

Manhole # S250\_\_004MH

Insp Date: **4/3/08 10:50 AM**

**Location** Address: **1313 BAYARD ST**

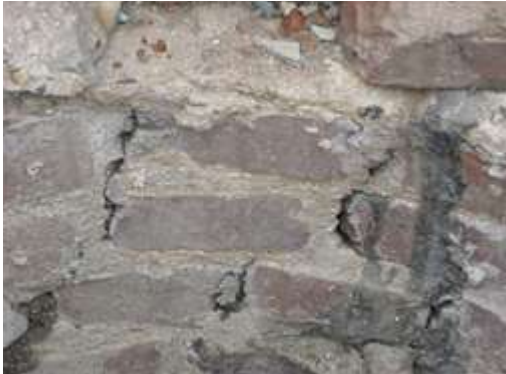
Defect 7

Condition: ☐ Sound ☐ Cracked ☐ Root Intrusion ☒ **Loose Brick** ☐ Deteriorated

Infiltration: ☐ None ☐ Joint ☒ **Cracks** ☐ Mortar ☐ Roots ☐ Wall

MISSING BRICK AND CRACKS WITH EVIDENCE OF INFILTRATION IN CHIMNEY

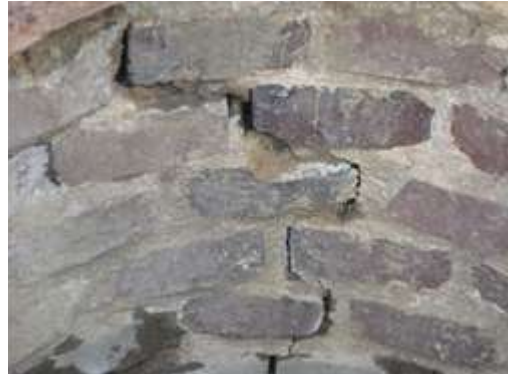
Defect 6

Condition: ☐ Sound ☒ **Cracked** ☐ Root Intrusion ☐ Loose Brick ☐ Deteriorated

Infiltration: ☐ None ☐ Joint ☒ **Cracks** ☐ Mortar ☐ Roots ☒ **Wall**

MISSING MORTAR AND CRACKS AT CORBEL WITH EVIDENCE OF INFILTRATION

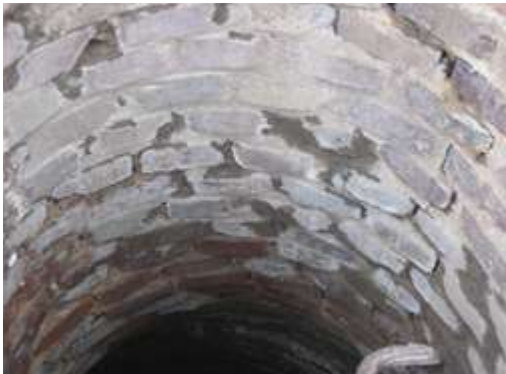
Defect 4

EVIDENCE OF INFILTRATION AT THE CORBEL AND BARREL

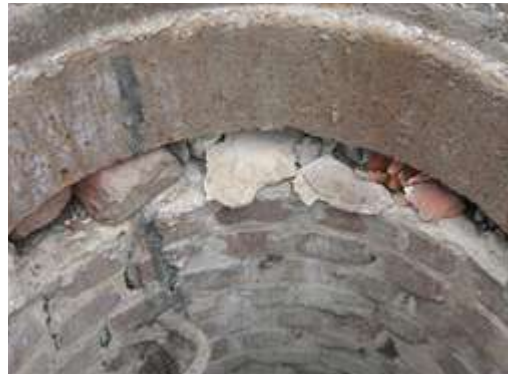
Defect 3

MISSING MORTAR AND CRACKS AT CHIMNEY

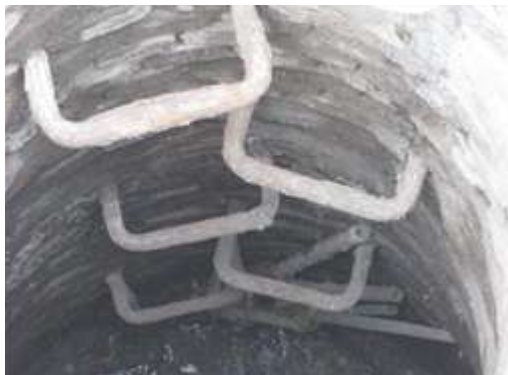
### Defect 2

**Steps** Count: **7** Missing: **0** ☒ **Corroded**

CORRODED STEPS

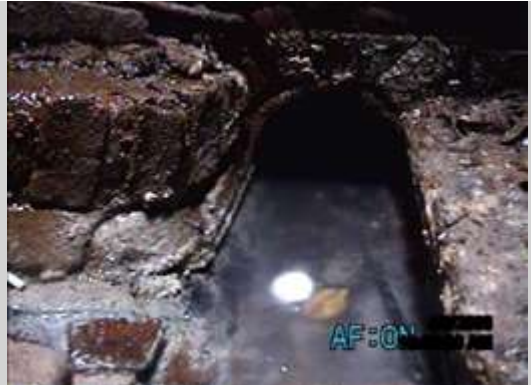
12 O'Clock Outflow

8 in. Circular Gravity Sewer  
Pipe Out @ 12 O'Clock

Pipe Height: **8.4** (in.) Rod and Bar (Angled)  
Pipe Material: **Clay** ☐ Pipe Lined  
Invert Depth: **12.23** (ft.) Flow Characteristics: **Fast**  
Deposits: ☒ None ☐ Mud ☐ Sludge ☐ Debris ☐ Grease  
Silt Depth: **0** (in.) Deposits Extent:  
Infiltration: **Evidence** Pipe Seal Cond: **Unknown**

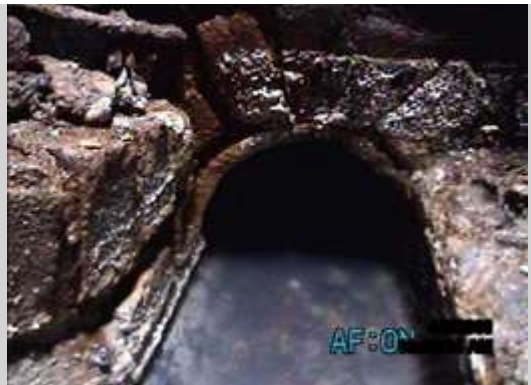
6 O'Clock Inflow

8 in. Circular Gravity Sewer  
Pipe In @ 6 O'Clock

Pipe Height: **8.4** (in.) Rod and Bar (Angled)  
Pipe Material: **Clay** ☐ Pipe Lined  
Invert Depth: **12.03** (ft.) Flow Characteristics: **Fast**  
Deposits: ☒ None ☐ Mud ☐ Sludge ☐ Debris ☐ Grease  
Silt Depth: **0** (in.) Deposits Extent:  
Infiltration: **Evidence** Pipe Seal Cond: **Unknown**

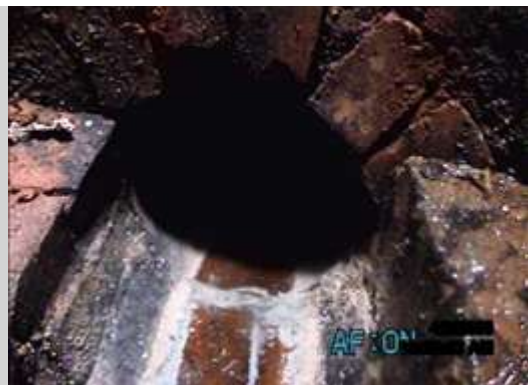
9 O'Clock Inflow

8 in. Circular Gravity Sewer  
Pipe In @ 9 O'Clock

Infiltration: **Evidence** Pipe Seal Cond: **Unknown**
